ROTAX. SERVICE INFORMATION

26 UL 94-E

TBO für ROTAX Motor Type 912 UL Serie

Increase of TBO from 600h or 10 years to 1200h or 15 years of operation.

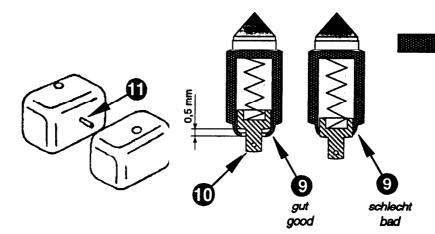
Examine float valve with float chamber removed. At visible wear of beaded edge at the spring pin the valve has to be renewed. If the distance becomes less than 0,5 mm (see illustration) the float level will be affected too. Check support pin of floats.

At heavy wear of float bracket contact faces, caused by excessive vibration, renew float and float bracket as required.
